DIGHTON OUTDOOR FACILITY AUDITS

KMA audited the following outdoor facilities:

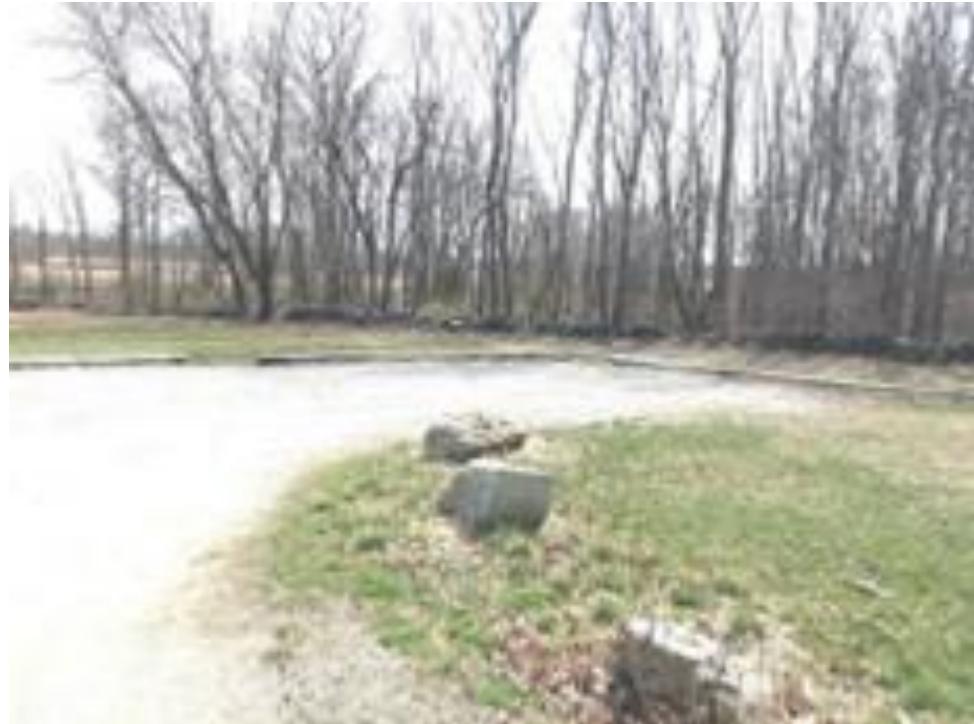
BROAD COVE NATURE TRAIL

KMA reviewed two entrances at the Broad Cove Nature Trail: the entrance off Hart Street and the West Entrance. Both entrances consist of an unpaved parking area with adjacent trailheads. No designated accessible parking spaces and no accessible routes are provided.

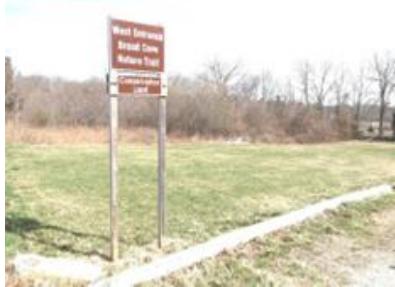
#	<i>Barrier Statement</i>	<i>Photo</i>	<i>Proposed Mitigation</i>	<i>Cost</i>
1.	Accessible Parking – Hart Street Entrance & West Entrance Designated accessible parking is not provided and the parking surface is not stable, firm, and slip resistant.

Pave a portion of the parking lot to add a van accessible parking spaces, as well as its associated sign and access aisle. Unit Cost: \$1,500 per space or aisle Est. Quantity: 4 (2 spaces + 2 aisles)	\$6,000
2.	Accessible Route – Hart Street Entrance & West Entrance An accessible route is not provided to the trail.

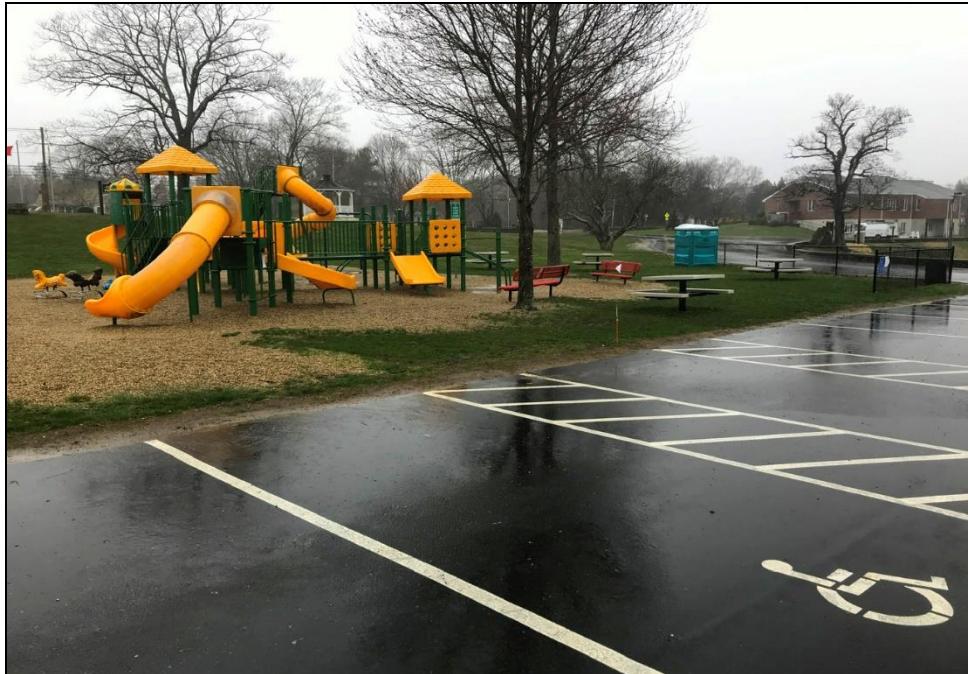
CENTRAL PLAYGROUND

Central Playground is located along Somerset Avenue. The site consists of an open green space, a playground, a gazebo, picnic table seating, and surface parking, including two designated accessible parking spaces. There is no accessible route from the public right-of-way to the site.

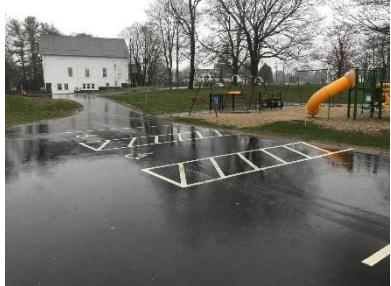
#	Barrier Statement	Photo	Proposed Mitigation	Cost
1.	<p>Accessible Parking</p> <p>The parking lot lacks a van accessible parking space. The access aisle is <96" wide, @ 60".</p>

<p>Restripe an existing parking space to add a van accessible space, as well as its associated sign and access aisle.</p> <p>Unit Cost: \$150 per space or aisle</p> <p>Est. Quantity: 2 (1 space + 1 aisle)</p>	\$300

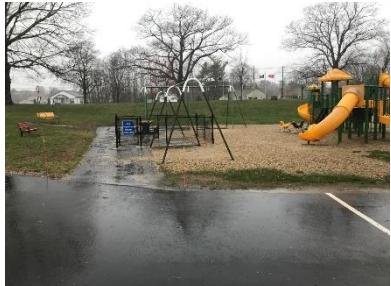
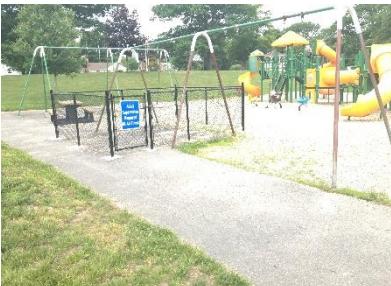
2.	<p>Accessible Route</p> <p>An accessible route is not provided to the playground.</p> <p>The playground lacks ground-level play components and an accessible route between elements.</p> <p>The gate to the enclosed area lacks the required minimum 10" AFF of smooth surface along the bottom of the push side.</p> <p><i>Note: there is an accessible swing area at the playground.</i></p>

<p>Provide an accessible route to the playground. Additional study required.</p> <p>Unit Cost: \$5,000</p> <p>Quantity: 1</p> <p>Provide ground-level play components at the playground. Additional study required.</p> <p>Unit Cost: \$1,000</p> <p>Quantity: 1</p> <p>Install a kick plate that is minimum 10" tall on the bottom of the push side of the gate.</p> <p>Unit Cost: \$250 ea.</p> <p>Quantity: 1</p>	\$6,250

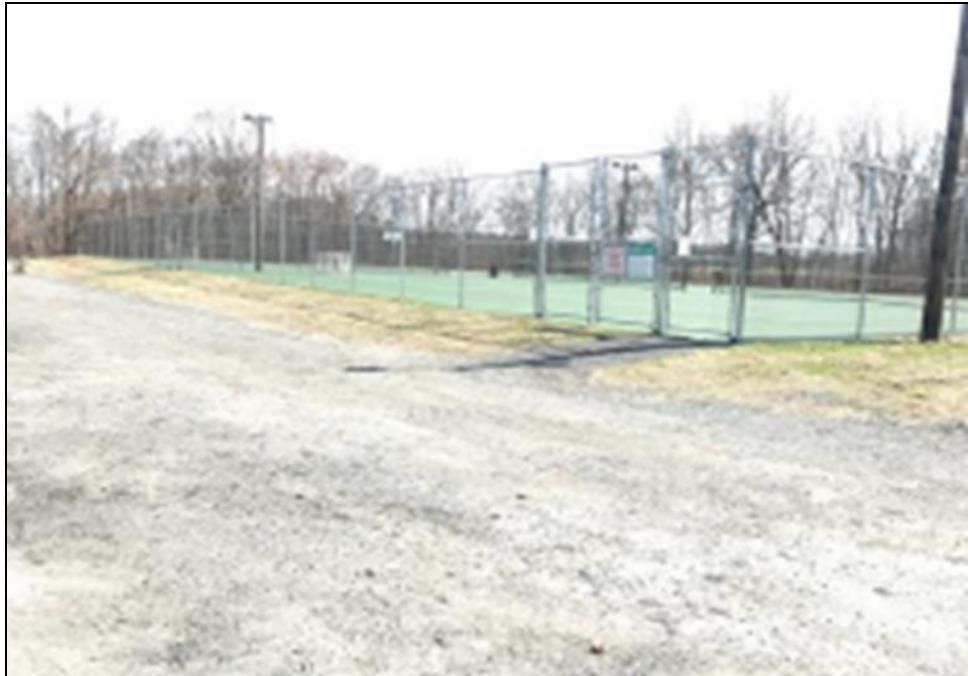
COURTS BY OLD POLICE STATION

The courts by the Old Police Station are located along Somerset Avenue. The site consists of a parking lot, a seating area, two tennis courts, a basketball court, a multi-purpose court, a portable toilet room, and surface parking. No accessible parking or accessible routes are provided.

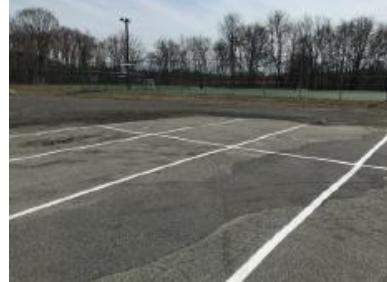
#	<i>Barrier Statement</i>	<i>Photo</i>	<i>Proposed Mitigation</i>	<i>Cost</i>
1.	Accessible Parking Designated accessible parking is not provided.

Restripe an existing parking space to add a van accessible space, as well as its associated sign and access aisle. Unit Cost: \$150 per space or aisle Est. Quantity: 2 (1 space + 1 aisle)	\$300
2.	Accessible Route An accessible route is not provided to the courts, the bleachers, the picnic tables, or the portable toilet room.

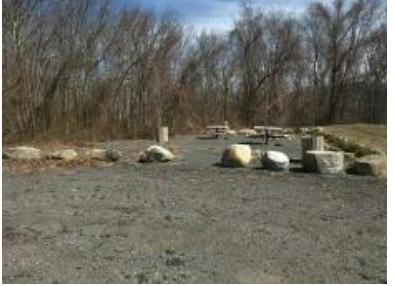
3.	Seating Area The outdoor tables lack an accessible seating location.

Provide at least one table, and no less than 5% of the total number of tables, that provides compliant knee and toe clearance. Unit Cost: \$250 ea. Est. Quantity: 1	\$250
4.	Portable Toilet An accessible portable toilet is not provided.

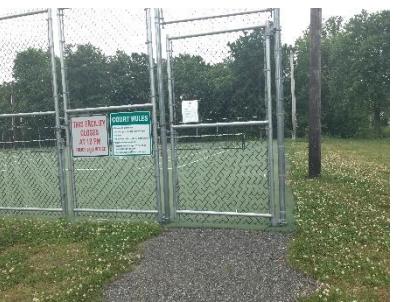
Provide an accessible portable toilet located on an accessible route. Unit Cost: \$1,500 per season Est. Quantity: 1	\$1,500
5.	Gates The gates lack the required minimum 10" of smooth surface along the bottom of the push side.

Install a kick plate that is minimum 10" tall on the bottom of the push side of the gate. Unit Cost: \$250 ea. Quantity: 2	\$500
TOTAL FOR COURTS BY OLD POLICE STATION:				\$7,550

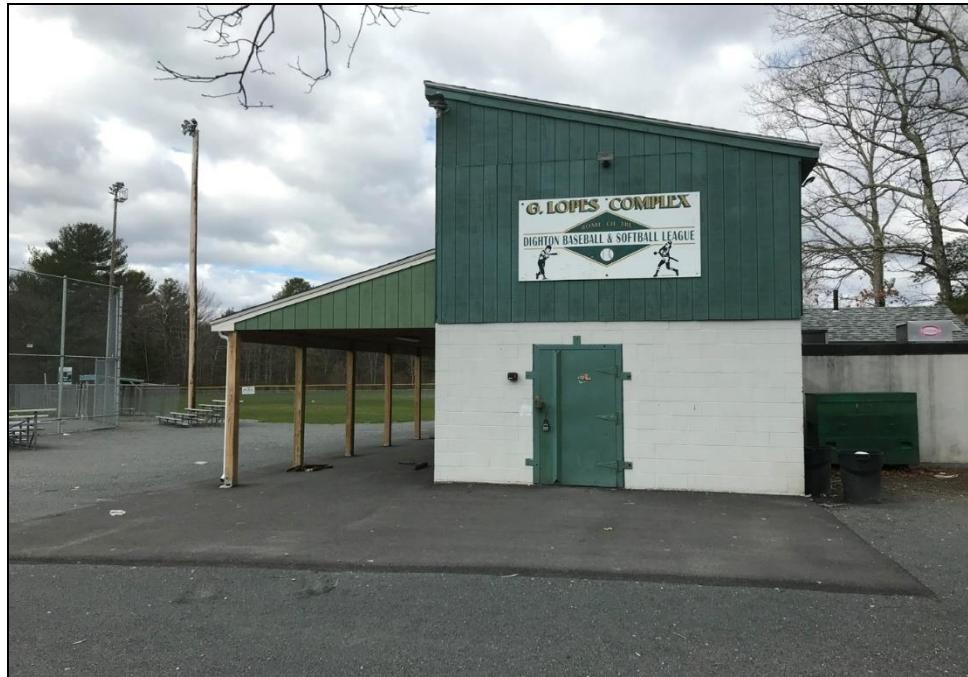
G. LOPEZ LITTLE LEAGUE COMPLEX

The G. Lopes Complex is located at 2580 Maple Swamp Road. The site consists of several athletic fields, a set of toilet rooms, a concessions pavilion, outdoor seating, and surface parking, including three designated accessible parking spaces.

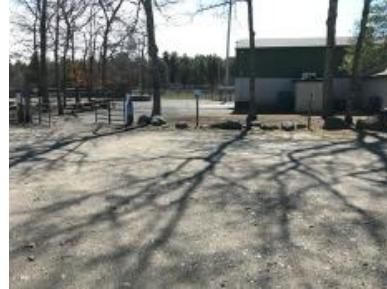
#	Barrier Statement	Photo	Proposed Mitigation	Cost
1.	<p>Accessible Parking</p> <p>The designated accessible parking provided lacks striping, a stable, firm and slip resistant surface.</p> <p>The signs are mounted <60" AFF to the bottom edge of the sign.</p>

<p>Pave a portion of the parking lot to add accessible parking spaces (including at least one van space), as well as their associated access aisles.</p> <p>Unit Cost: \$1,500 per space or aisle Est. Quantity: 5 (3 spaces + 2 aisles)</p> <p>Reinstall the signs at min. 60" AFF, measured to the bottom of the sign, including a van accessible sign.</p> <p>Unit Cost: \$100 ea. Quantity: 3</p>	\$7,800

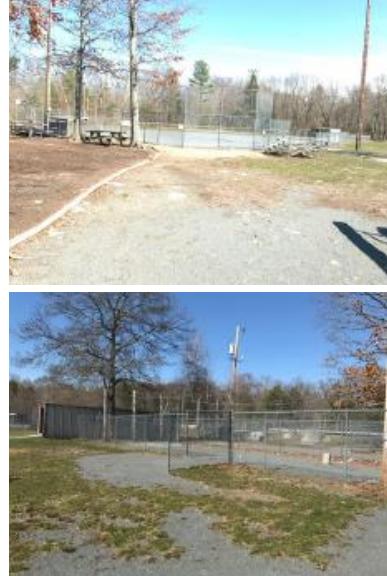
2.	<p>Accessible Route</p> <p>An accessible route is not provided to the fields, the benches, the bleachers, the toilet rooms, the picnic tables, or the service window.</p> <p>The outdoor tables lack an accessible seating location.</p> <p>A wheelchair space is not provided at the bleachers.</p>

<p>Provide an accessible route. Additional study required.</p> <p>Unit Cost: \$10,000 Quantity: 1</p> <p>Provide at least one table, and no less than 5% of the total number of tables, that provides compliant knee and toe clearance.</p> <p>Unit Cost: \$250 ea. Est. Quantity: 1</p> <p>Provide an accessible wheelchair space on an accessible route next to the bleachers.</p> <p>Unit Cost: \$25/SF Quantity: 20 SF</p>	\$10,750

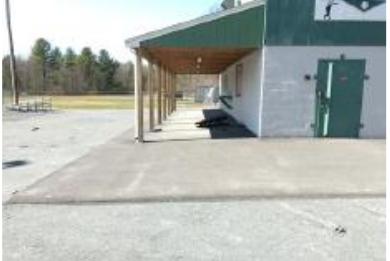
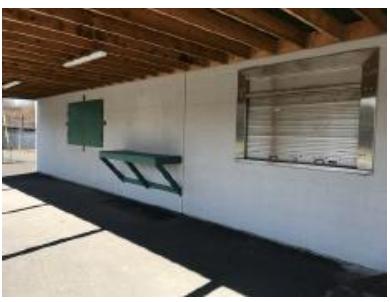
3.	<p>Service Window</p> <p>The service area is not located on an accessible route due to a vertical change in level >0.25" AFF, @ 2".</p> <p>The service window and the counter are >36" AFF, @ up to 39".</p>

<p>Coordinate with mitigation above regarding proving an accessible route.</p> <p>Unit Cost: \$0</p> <p>Quantity: -</p> <p>Lower the service window and counter to max. 36" AFF.</p> <p>Unit Cost: \$3,000</p> <p>Quantity: 1</p>	\$3,000
----	---	--	---	---------

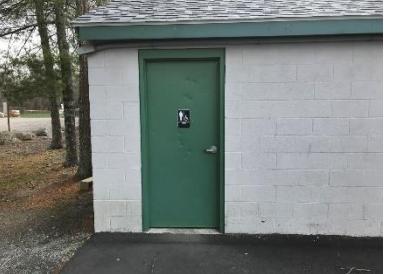
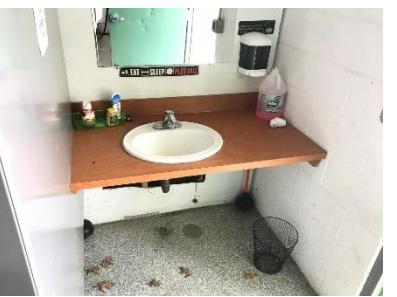
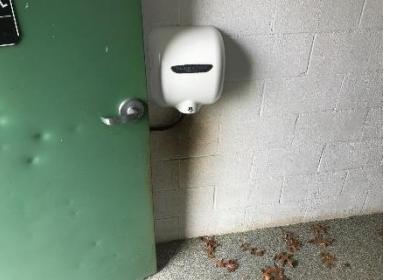
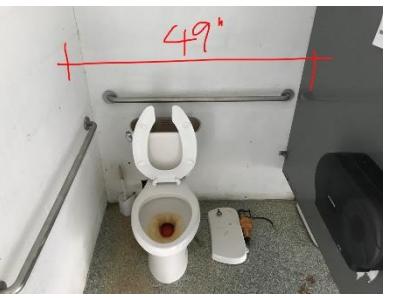
4.	<p>Toilet Rooms (2)</p> <p>The signs are not located on the latch side of the door.</p> <p>The knee clearance at the sink is <27" AFF, @ 25".</p> <p>The mirror is >40" AFF to the bottom of the reflective surface, @ 43.5".</p> <p>The dryer protrudes >4" into the circulation space, @ 8".</p> <p>The distance from the toilet centerline to the adjacent stall partition is <42".</p> <p>The side grab bar extends <54" from the rear wall, @ 48".</p> <p>The coat hook is >48" AFF, @ 65".</p>

<p>Install tactile/ Braille signage on the latch side of the door. Coordinate with location and height requirements.</p> <p>Unit Cost: \$100 per sign</p> <p>Quantity: 2</p> <p>Raise the vanity to provide the required knee clearance.</p> <p>Unit Cost: \$750 ea.</p> <p>Quantity: 2</p> <p>Lower the mirror.</p> <p>Unit Cost: \$50 ea.</p> <p>Quantity: 2</p> <p>Relocate the dryer.</p> <p>Unit Cost: \$250 ea.</p> <p>Quantity: 2</p> <p>Relocate the stall partition.</p> <p>Unit Cost: \$900 ea.</p> <p>Quantity: 2</p> <p>Install a 42" min. side grab bar, located 12" from the interior corner of the wall.</p> <p>Unit Cost: \$50 ea.</p> <p>Quantity: 2</p> <p>Install a coat hook mounted no higher than 48" AFF.</p> <p>Unit Cost: \$50 ea.</p> <p>Quantity: 2</p>	\$4,300

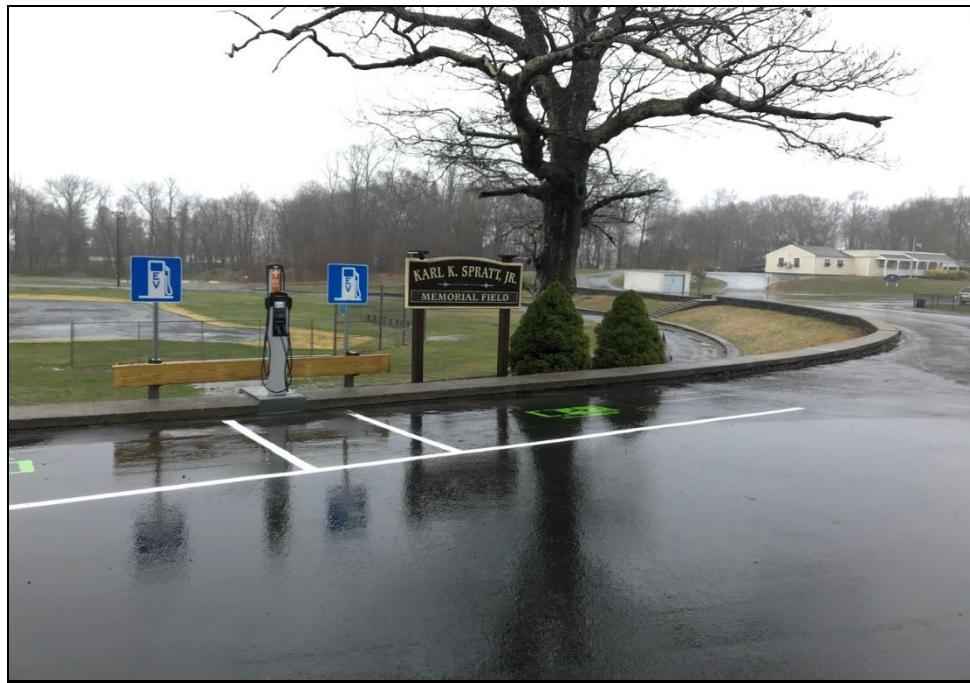
KARL SPRATT JR. MEMORIAL FIELD

Karl Spratt Jr. Memorial Field is located behind Town Hall off of Somerset Avenue. The site consists of an open green space and an athletic field enclosed by a running track and stepped seating. Surface parking is available at adjacent Town Hall. KMA did not observe any designated accessible parking spaces serving the field. There is no accessible route provided from the public right-of-way to site elements.

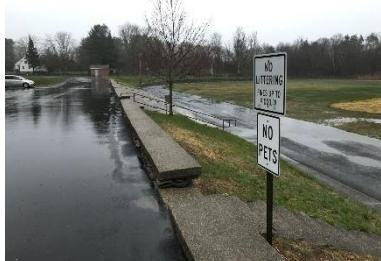
2.	Accessible Route An accessible route is not provided to the track or field.

Provide an accessible route. Additional study required. Unit Cost: \$5,000	\$5,000

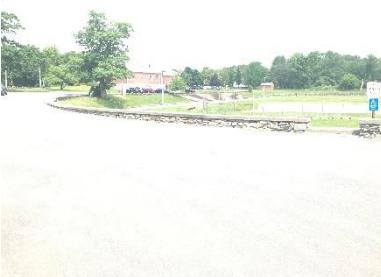
3.	Stadium Seating The stadium lacks the total number of required accessible seating spaces.

Provide the required number of accessible seats. Further design study required. Unit Cost: \$5,000	\$5,000

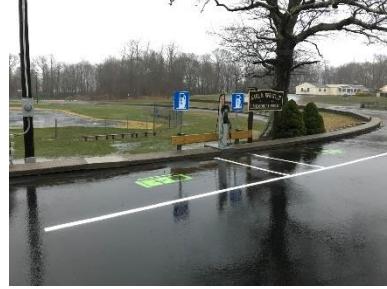
4.	EV Charging Stations The EV charging controls are >48" AFF.

Relocate the controls to max. 48" AFF. Unit Cost: \$1,000 ea. Quantity: 1	\$1,000
TOTAL FOR KARL SPRATT JR. MEMORIAL FIELD:				\$11,700

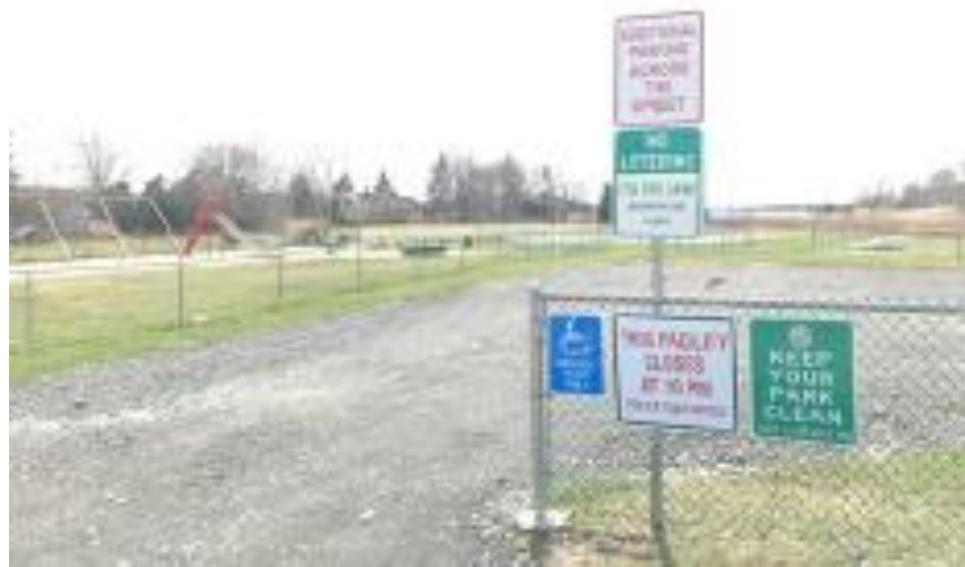
LANE FIELD

Lane Field is located on Main Street. The site consists of an open green space, a playground, benches, and a baseball field. KMA did not observe any designated parking spaces or accessible spaces serving the field. There is no accessible route from the public right-of-way.

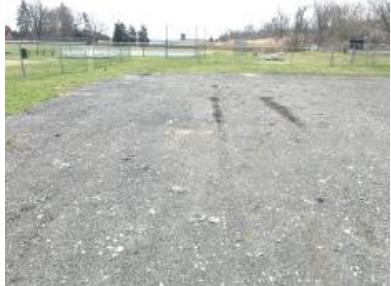
#	Barrier Statement	Photo	Proposed Mitigation	Cost
1.	Accessible Parking Designated accessible parking is not provided and the parking surface is not stable, firm, and slip resistant.

Pave a portion of the parking lot to add a van accessible parking space and its associated access aisle. Unit Cost: \$1,500 per space or aisle Est. Quantity: 2 (1 space + 1 aisle) Install a sign at the head of the designated van accessible space, @ min. 60" AFF to the bottom of the sign. Unit Cost: \$100 ea. Quantity: 1	\$3,100

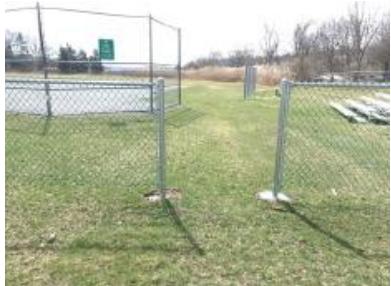
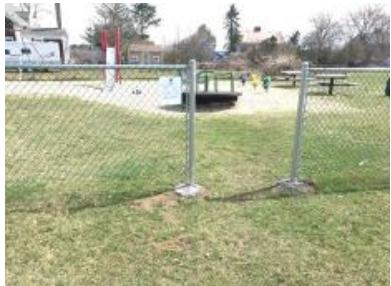
2.	Accessible Route An accessible route is not provided to the baseball field, the bleachers, the playground, or the benches. A wheelchair space is not provided at the bleachers. The playground lacks ground-level play components and an accessible route between elements.

Provide an accessible route. Additional study required. Unit Cost: \$5,000 Quantity: 1 Provide an accessible space on an accessible route next to the bleachers. Unit Cost: \$25/SF Quantity: 20 SF Provide ground-level play components at the playground. Additional study required. Unit Cost: \$1,000 Quantity: 1	\$6,500
TOTAL FOR LANE FIELD:				\$9,600

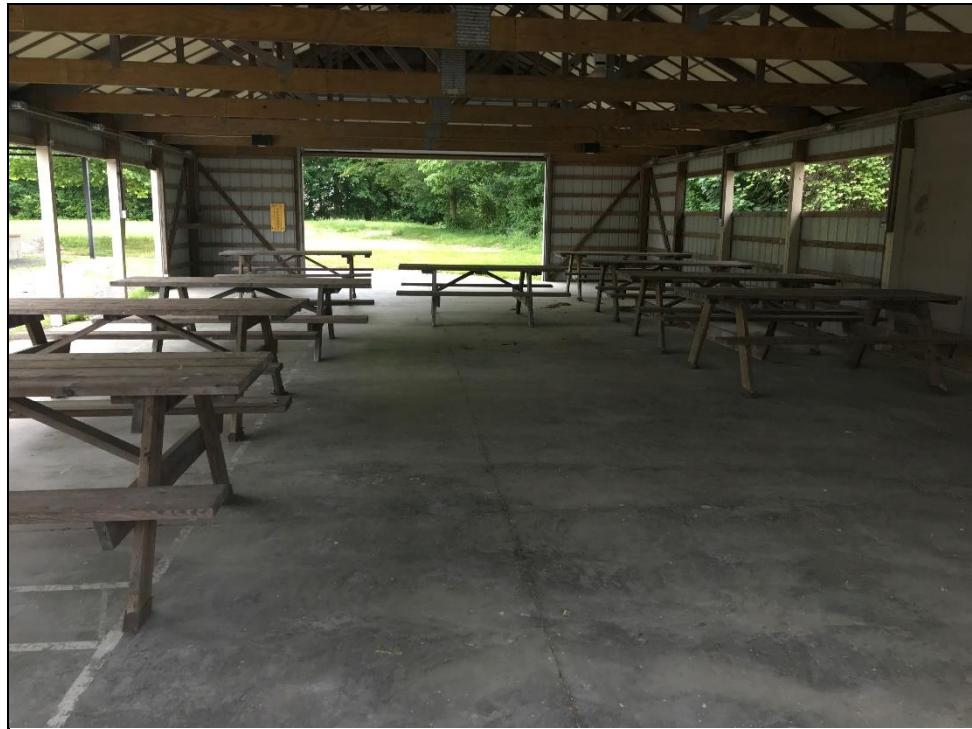
LIONS CLUB PAVILION

The Lions Club Pavilion is located behind Old Town Hall. The site consists of a covered seating area, a portable toilet, and a grilling area. KMA was informed on site that the Lions Club Pavilion shares parking with the adjacent Town facilities.

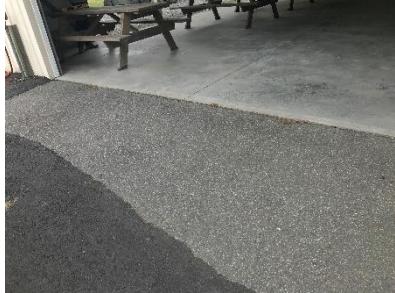
#	Barrier Statement	Photo	Proposed Mitigation	Cost
3.	Accessible Route The walkway leading into the pavilion has running slopes >5%, @ up to 9.4%.

Provide an accessible route. Additional study required. Unit Cost: \$1,000 Quantity: 1	\$1,000

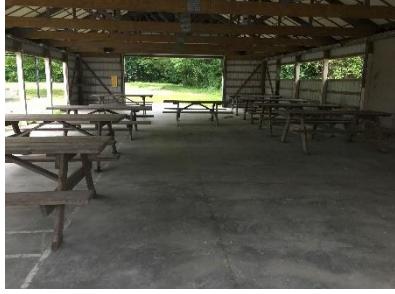
4.	Seating There are no accessible seating spaces provided.

Provide at least one table, and no less than 5% of the total number of tables, that provides compliant knee and toe clearance. Unit Cost: \$250 ea. Est. Quantity: 1	\$250

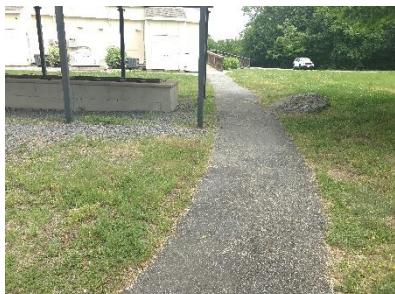
5.	BBQ Area The BBQ area is not on an accessible route. The paved path at the back has running slopes >5%, @ up to 7.7%. The BBQ area lacks an adjacent level clear floor space.

Provide an accessible route. Additional study required. Unit Cost: \$1,000 Quantity: 1 Provide an accessible space on an accessible route next to the BBQ. Unit Cost: \$25/SF Quantity: 20 SF	\$1,500
TOTAL FOR LIONS CLUB PAVILION:				\$2,750

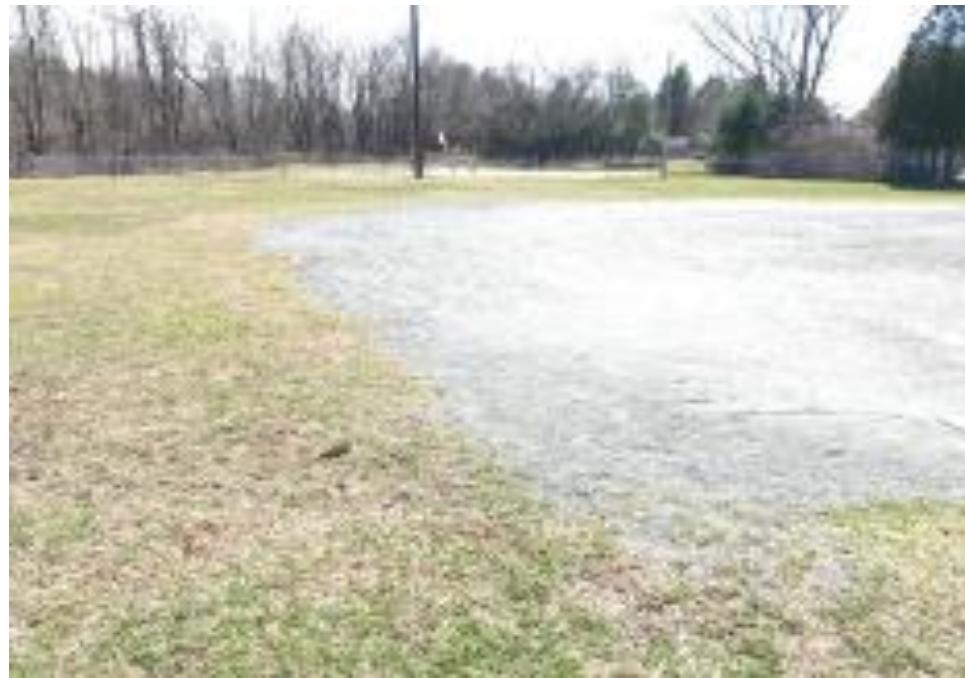
NORTH DIGTON FIELD

North Dighton Field is located at the intersection of Prospect Street and School Street. The site consists of a baseball field and a basketball court. No designated accessible parking is provided.

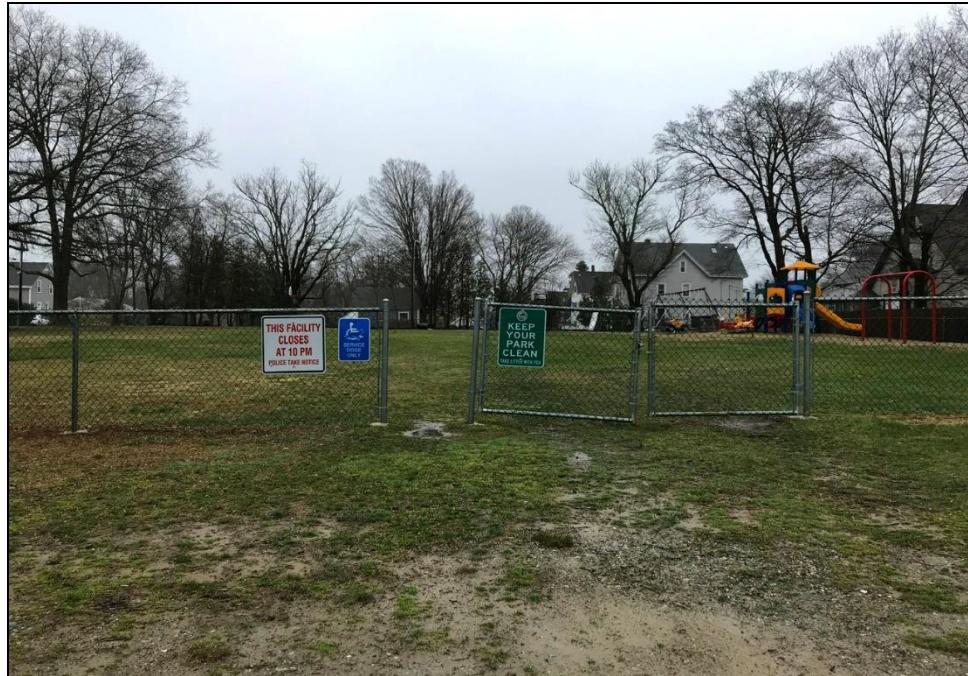
PALMER STREET PLAYGROUND

Palmer Street Playground is located at the intersection of Palmer Street and School Lane. The site consists of a playground and a basketball court. There is no designated accessible parking or accessible routes provided on site.

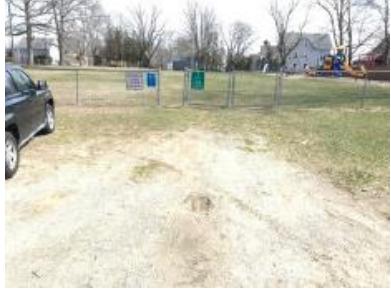
#	<i>Barrier Statement</i>	<i>Photo</i>	<i>Proposed Mitigation</i>	<i>Cost</i>
1.	Accessible Parking Designated accessible parking is not provided and the parking surface is not stable, firm, and slip resistant.

Pave a portion of the parking lot to add a van accessible parking space and its associated access aisle. Unit Cost: \$1,500 per space or aisle Est. Quantity: 2 (1 space + 1 aisle) Install a sign at the head of the designated van accessible space, @ min. 60" AFF to the bottom of the sign. Unit Cost: \$100 ea. Quantity: 1	\$3,100

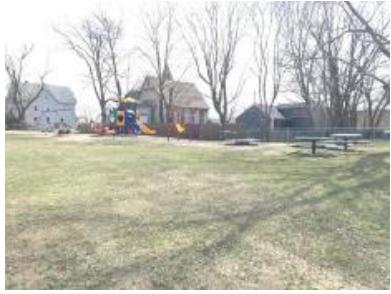
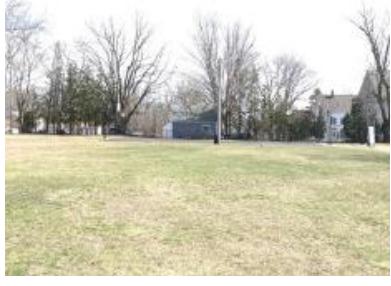
2.	Accessible Route An accessible route is not provided to the playground or outdoor seating. The playground lacks ground-level play components and an accessible route between elements.

Provide an accessible route to the playground and seating. Additional study required. Unit Cost: \$1,000 Quantity: 1 Provide ground-level play components at the playground. Additional study required. Unit Cost: \$1,000 Quantity: 1	\$2,000

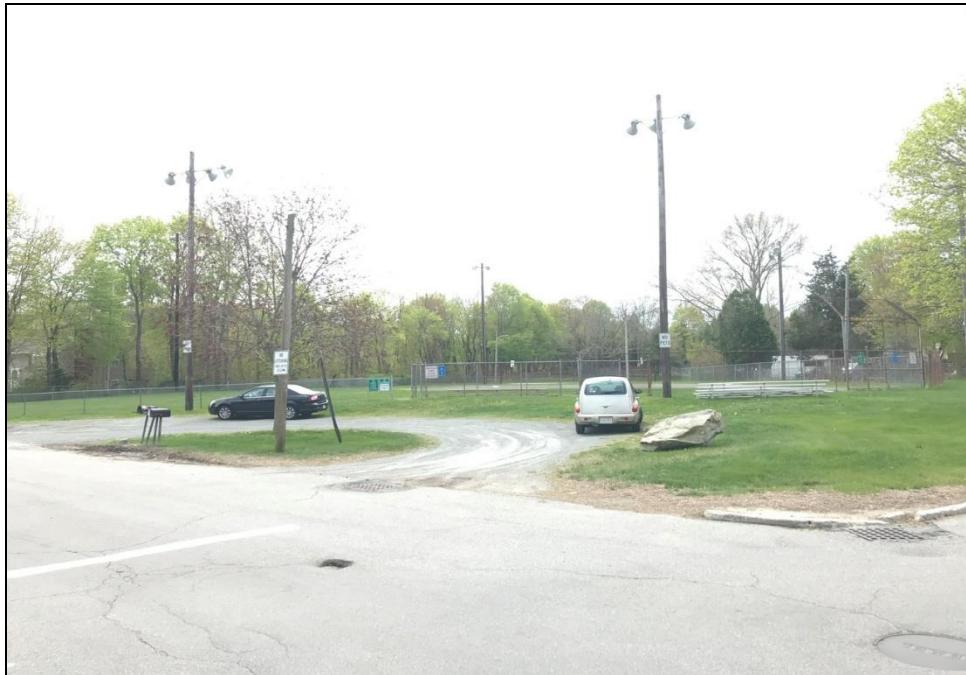
SCHOOL STREET PLAYGROUND

School Street Playground is located at the intersection of Prospect Street and School Street. The site consists of a baseball field, a basketball court, and an unpaved lot used for parking. There are no designated accessible routes provided from the parking area to and within the site.

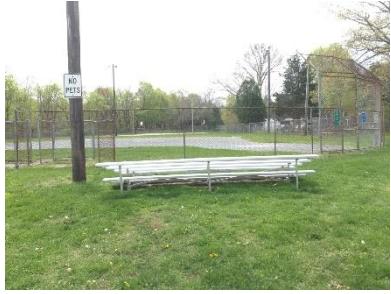
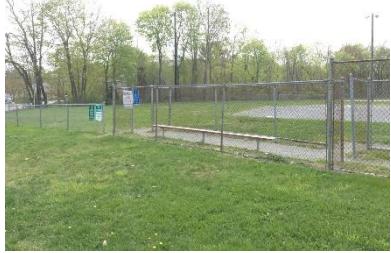
2.	Accessible Route An accessible route is not provided to the bleachers, the baseball field, or the basketball court. A wheelchair space is not provided at the bleachers.

Provide an accessible route. Additional study required. Unit Cost: \$5,000 Provide an accessible wheelchair space on an accessible route next to the bleachers. Unit Cost: \$25/SF Quantity: 20 SF	\$5,500
TOTAL FOR SCHOOL STREET PLAYGROUND:				\$8,600

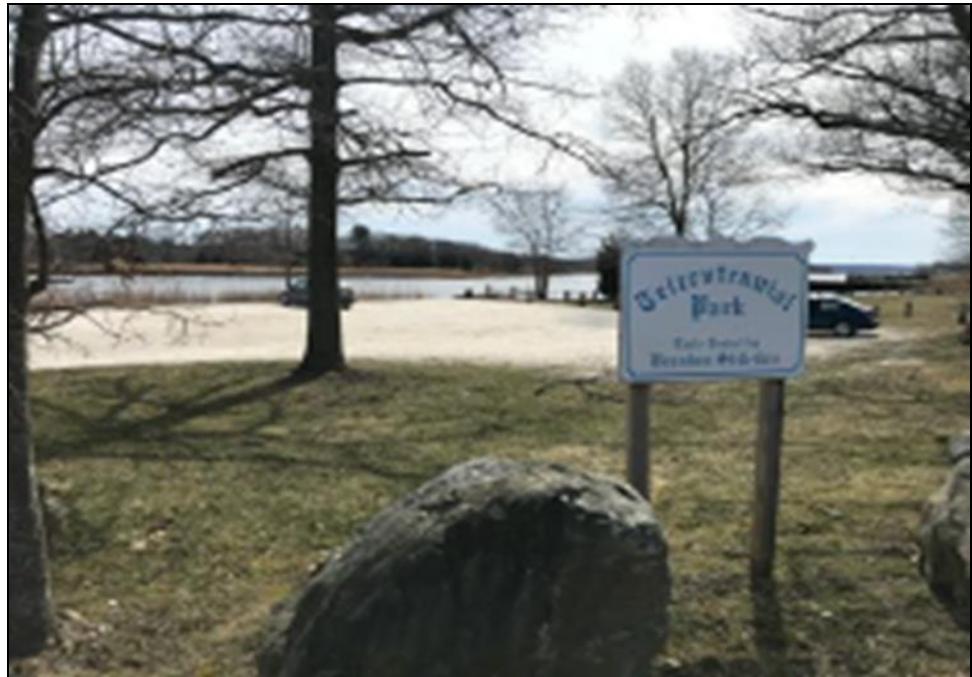
TRICENTENNIAL PARK

Tricentennial Park is located along Pleasant Street. The site consists of a park and an unpaved lot used for parking. There are no designated accessible routes provided from the parking area to and within the site.

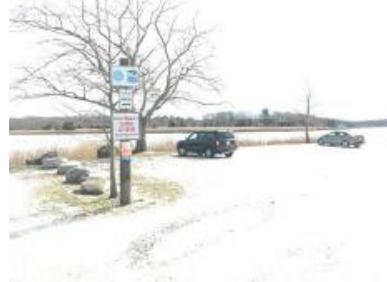
#	<i>Barrier Statement</i>	<i>Photo</i>	<i>Proposed Mitigation</i>	<i>Cost</i>
3.	Accessible Parking Designated accessible parking is not provided and the parking surface is not stable, firm, and slip resistant.

Pave a portion of the parking lot to add a van accessible parking space, as well as its associated sign and access aisle. Unit Cost: \$1,500 per space or aisle Est. Quantity: 2 (1 space + 1 aisle) Install a sign at the head of the designated van accessible space, @ min. 60" AFF to the bottom of the sign. Unit Cost: \$100 ea. Quantity: 1	\$3,100

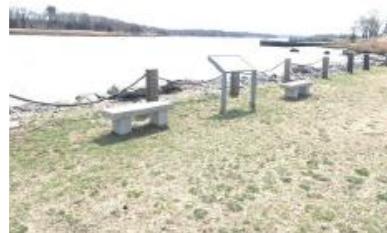
4.	Accessible Route An accessible route is not provided to the benches, picnic tables, or description placard. The accessible seating spaces at the picnic tables lack the required stable, firm, and slip resistant surface below.

Provide an accessible route. Additional study required. Unit Cost: \$5,000 Est. Quantity: 1 Pave the areas at the accessible seating spaces to provide at least one table, and no less than 5% of the total number of tables, that provides compliant knee and toe clearance. Unit Cost: \$500 ea. Est. Quantity: 1	\$5,500
TOTAL FOR TRICENTENNIAL PARK:				\$8,600
TOTAL FOR DIGTON EXTERIOR AREAS:				\$103,400
